## Leak from the vaporizer- An unusual cause

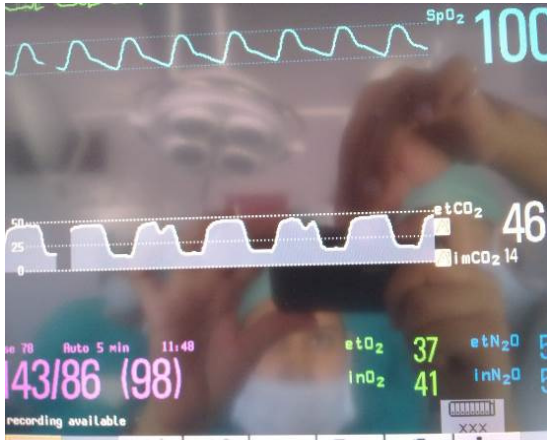
Figure 1

Editor- Modern day vaporizers are reliable and come with many safety features. But still human errors are inevitable. We report an incident of an unusual leak from the vaporizer unit. A 40 year old 50 kg female was undergoing an open cholecystectomy under general anaesthesia. She was the 3<sup>rd</sup> case on the surgical list. Penlon Sigma Delta isoflurane vaporizer was refilled during the 2<sup>nd</sup> case. Patient was induced intravenously and anaesthesia was maintained with 60% nitrous oxide, 40% oxygen and 1% isoflurane. After 10 minutes we noticed that inspiratory mean CO<sub>2</sub> (imCO<sub>2</sub>) was 18 mmHg and end tidal CO<sub>2</sub> (EtCO<sub>2</sub>) was 42 mmHg. (Figure 1) Patient was being ventilated with the penlon S2 ventilator via closed circuit. Ventilator settings were 400 ml tidal volume, 12/min respiratory rate and inspiratory to expiratory ratio 1:2. Fresh gas flow (FGF) was 2 L/min with oxygen: nitrous oxide ratio of 40:60. Soda lime was checked and found to be fresh. The difference between inspired and exhaled tidal volume was not significant. Monitor showed a MAC value of 0.4 with isoflurane vaporizer dial setting of 1%. FGF was increased, but did not result in change in imCO<sub>2</sub>. Connections within and between the circuit, the common gas outlet and filler cap of the vaporizer were checked for leaks. We found that the filler plug of the vaporizer was hanging down and the clamp screw was loose. (Figure 2) Some of the FGF was leaking through that window. After the filler plug was repositioned and clamp screw tightened, the problem was rectified. Vaporizer had been filled during the 2<sup>nd</sup> case by OT attendant. Probably filler plug was loosely placed but not enough to cause a FGF leak during the 2<sup>nd</sup> case. During the 3<sup>rd</sup> case the thread of filler plug was probably pulled inadvertently and it fell down as clamp screw was not tightened adequately.

Our incident is to reinforce the fact that one should check the low pressure system for leaks using a negative- pressure leak test after vaporizers are refilled and also with vaporizer

concentration dial turned on. Operator's manual instructs the user to close the fill valve and to fully insert and tighten the filler-port plug in place after filling; anaesthesia care providers need to be aware of the consequences of not following this instruction.
