Defective Y

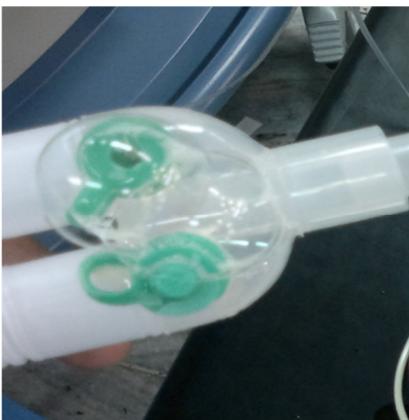
We are reporting a case of unusual cause of significant leak leading to failure of self-test. Before starting the first case in morning schedule, the breathing tubes supplied by manufacturer were changed with alternate disposable light weight breathing tubes for orofacial surgery. Dräger primus anaesthesia machine was then subjected to routine machine self-test. It was found that the machine was not able to complete the machine check and showed a failure in leak test. All the connections of the end tidal carbon dioxide monitoring tubing, elbow connector, hoses, soda lime canister, vaporizer and breathing bag were checked, for probable site for the leak. We also checked for moisture in the flow sensor and condenser. All connections were intact and vaporizers were correctly placed and set at zero mark, and y connector was snugly shut. On using the machine in manual mode at flow of 4 liter/min and pressing the breathing bag, a hissing sound was heard from the patient end of the breathing circuit. Savlon was applied to the circuit with gauze and it showed bubbling from the plastic blocker near the patient end. Close inspection revealed a very small puncture hole of approximately 1 mm diameter on the plastic blocker of one of the ports on the “Y” connector

of the breathing circuit. On replacing this blocker with an intact one and redoing the leak test, the machine passed the test.

We suggest that one should always check for integrity of the breathing circuits along with the routine machine checks before giving anaesthesia.
