Removal of a retained guide wire in a critically ill patient with coagulopathy and cardiac instability

Loss of a guide wire in the venous system is a dreaded complication following central venous catheter insertion. Removal can be even more challenging in a patient with haemodynamic instability, acute kidney injury and thrombocytopenia. We report a case of successful removal of a retained guide wire lodged in the superior vena cava using correctly timed interventional radiology.

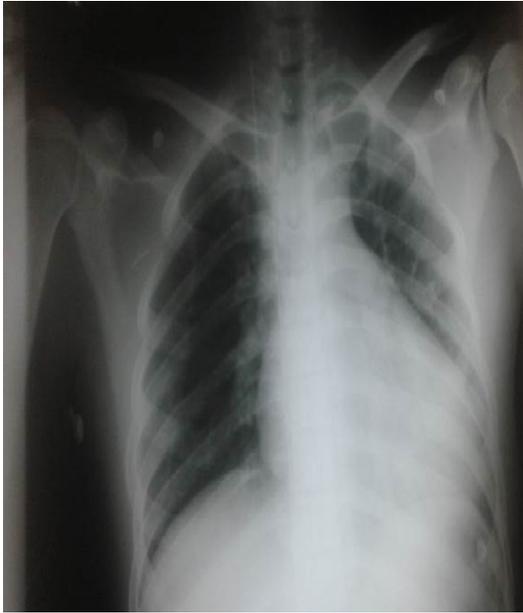
Figure 1

Following stabilization a chest X-ray was taken (Figure 1), which showed that the guidewire tip had migrated via inferior vena cava and was lodging in the superior vena cava.

Eight days later patient was haemodynamically stable, vasopressors were tailed off, acute kidney injury (AKI) had resolved and platelet counts improved up to 100,000/mm³. A multidisciplinary team decision was taken to remove the guide wire under radiology guidance. It was removed using a goose-neck snare via right internal jugular vein catheter. Contrast material was avoided due to recent AKI. He had an uneventful recovery and 48hrs later he was discharged from hospital.
