Intraoperative Endotracheal Tube Cuff Deflation - Stitch in Time Saves Nine!

An endotracheal tube is an integral part of general anaesthesia especially in long duration head and neck surgeries. Often, in such surgeries, the airway is shared by the surgeon and the anaesthetist. Any damage to the Endotracheal tube cuff may cause improper ventilation and airway contamination. We propose an algorithm through this case to prevent such complications and correct them if they happen.

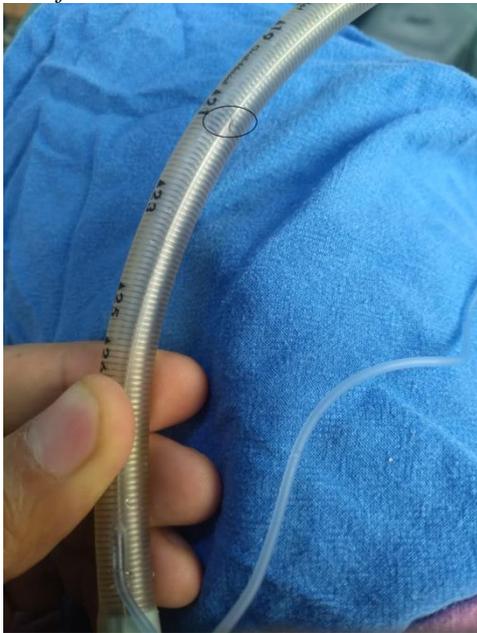
Checking the ETT inflation apparatus, after removing it confirmed our diagnosis of a defect within the cuff inflation system itself, however, we could not ascertain the modus and site of damage. Upon attempting to inflate the cuff with air while placing the whole tube in the water a small leak from the intra-tubal part of the inflation line of ETT was detected. (Figure 1).

Figure 1: Figure of ETT inflation apparatus with defect

surgeon resulting in intra-operative leaks, especially in head and neck surgeries. However, a leak due to damage to flexo-metallic ETT at this particular site i.e., at the intratubal segment of the inflation line as experienced in our case is rare and less described.

This experience led us to formulate and propose a set of protocols for preventing such occurrences (second category of causes of endotracheal cuff leaks as described by El-Orbany et al) and handling them should they occur. First set of protocols included ETT intubation and protection of the Endotracheal tube. In the case of nasotracheal intubation, we

suggest intubation through the contralateral nostril over the ipsilateral one. In the event of intubation via the ipsilateral nostril (in conditions like deviated nasal septum or nasal spur on the preferred side), the ETT should be rotated so as to place the take-off point of the pilot balloon away or towards opposite side from the surgeons' field while carefully avoiding any change in intratracheal cuff position. Along with these precautions, the habit of regularly checking
